## Best Management Practice Demonstration Horse Farm

## Construction of the Biofiltration Swale

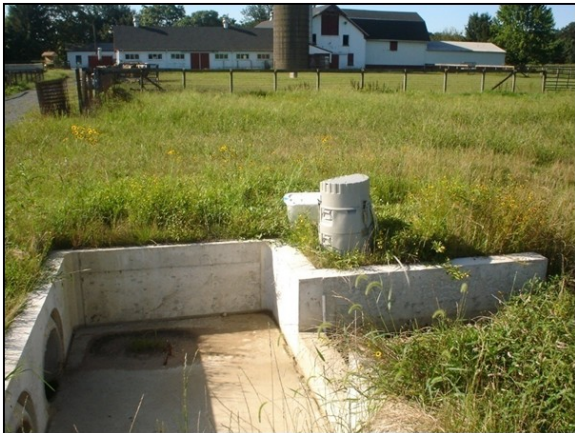
Monitoring equipment at the inlet of the swale

- This swale is equipped with monitoring equipment to document how effective the project has been at improving the water quality of the runoff:
  - ⇒ Two automatic samplers have been set up by the inlet and outlet of the bioswale to monitor the elevation of the water at the inlet and outlet. Researchers will calculate the amount of water that travels through the inlet.

- ⇒ The automatic samplers are programmed to collect water samples every thirty minutes during a rain storm. The samples from the inlet and the outlet will be analyzed for nutrients and bacteria.

- ⇒ The results from the nutrient and bacteria tests will be compared (inlet versus outlet) to look at improved water quality as the runoff travels through the bioswale. The flow calculations at the inlet and outlet will be used to measure any infiltration that occurs in the bioswale.

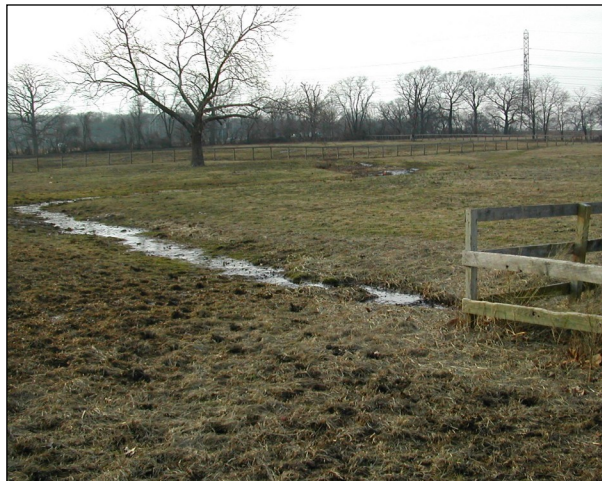
*Before the bioswale*

- Stormwater management is a growing concern for equine facilities.
- Regulators are concerned that stormwater runoff carries nutrients and pathogens from these facilities into local streams and lakes.
- Equine facilities can be considered a potential source of bacteria and nutrients for non-point source pollution.
- As the runoff water travels over the surface of an equine facility it collects soil, nutrients and bacteria from the surface.
- The runoff from the Demonstration Horse Farm flowed through a pipe that led directly to Weston's Mill Pond. The runoff was not treated before it was discharged. The runoff carried the soil, nutrients and bacteria with it when it flowed into the pond, thereby threatening the health of this waterway.

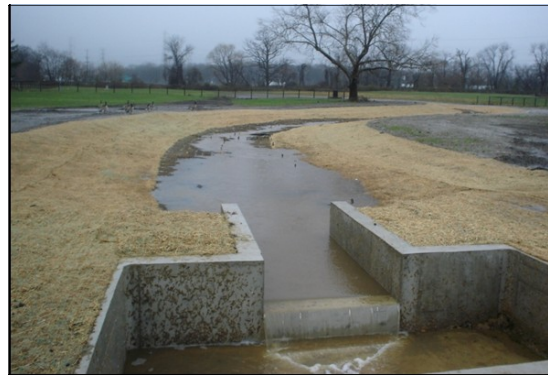
*Shortly after bioswale construction*

The Demonstration Horse Farm bioswale was designed and constructed to collect the stormwater runoff from the surrounding paddocks and treat it before the water is discharged to the local waterway.

- The bioswale is 33 feet wide and 850 feet long. The swale begins upstream of the roadway and travels underneath the road to the end of the farm to a stormwater sewer inlet.
- A sandy soil mix with a 10 to 15% organic content was used in the bottom of the bioswale, which was covered with erosion control matting.
- Native grasses (soft rush and switchgrass) were planted along the berm and bottom of the swale.
- The bioswale was designed to handle the stormwater runoff from the paddock that would result from a New Jersey Water Quality Design Storm (1.25 inches of rain over two hours).

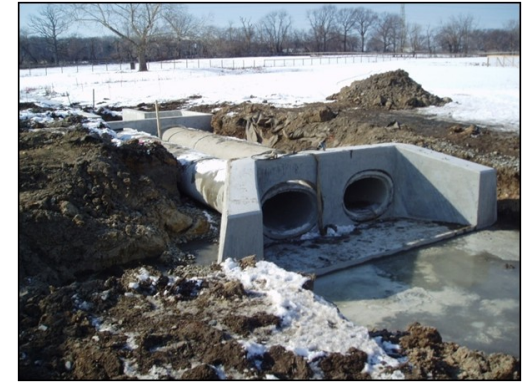
*Two pipes allow the swale to go under a farm road*

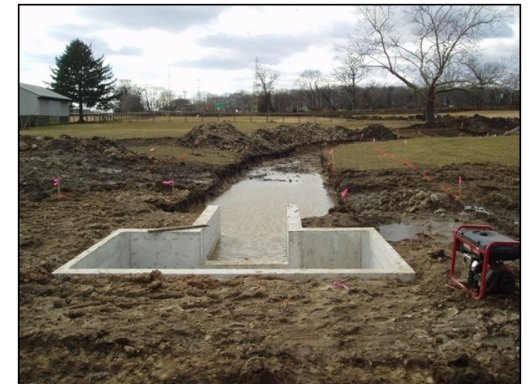
*Digging the channel*

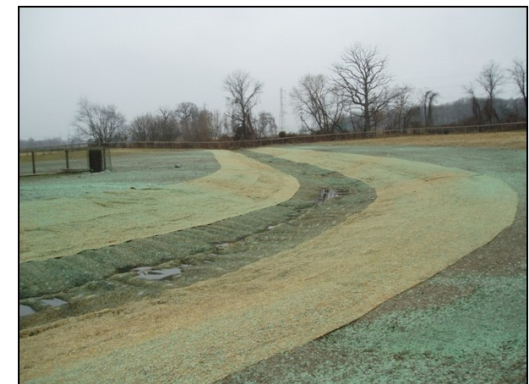
*The channel has been graded, seeded, and had erosion control matting added*
