Best Management Practice Demonstration Horse Farm

Construction of Paddock Drainage (Dry Wells)

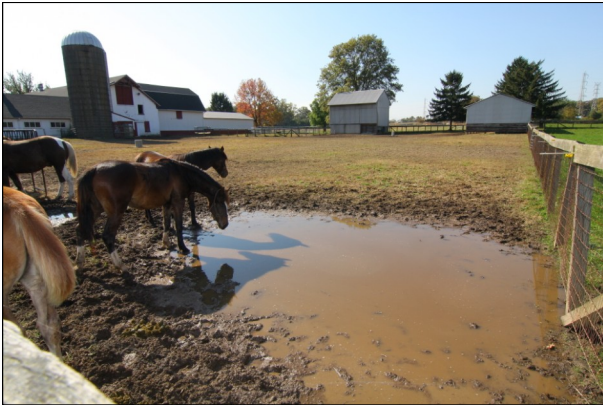
Before dry wells

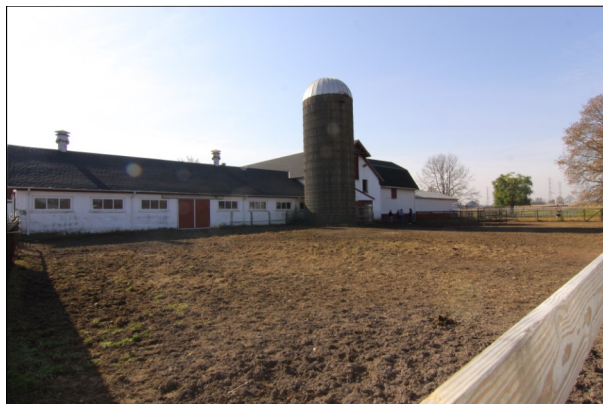
- Rain water no longer flows through the paddock on its way to the waterways, and in turn, no longer ponds there.
- The impact of pollution being carried to the local stream and the threat to horse health is minimized.
- This project represents a relatively simple, inexpensive and effective strategy for reducing contaminated runoff and maintaining the structural quality of a paddock area.

After dry wells

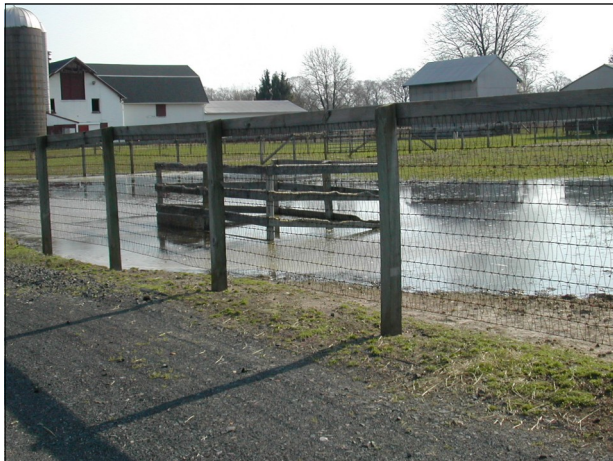
- Stormwater management is a growing concern for equine facilities.
- Regulators are concerned that stormwater runoff carries nutrients and pathogens from facilities into local streams and lakes.
- Paddocks that are adjacent to barns at the Demonstration Horse Farm were the main area of concern.
- The gutter/downspout system on the barn captured relatively clean stormwater runoff from the roof.
- Downspouts discharged the runoff onto the paddock where manure was present.
- Clean water ran through the paddock, mixing with the manure and carrying pollutants off site.
- Additionally, this system of managing roof top runoff made for a muddy paddock, which can have negative health implications for the horses.
- Rain water that landed on the paddock continued to wash soil and manure into a drainage ditch that discharged to a local stream, thereby threatening the health of this waterway.

Drainage problem

- The Rutgers Cooperative Extension Water Resources Program designed an infiltration system to allow rain water from small storms to infiltrate into the ground.

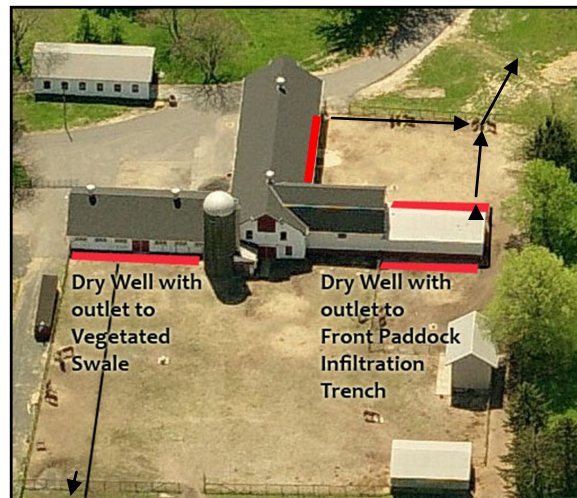
Construction

- Six inches of clean $\frac{3}{4}$ inch stone was placed in the trench and four-inch diameter perforated PVC piping was placed on top of the stone.
- Additional stone was used to place six inches of cover on the pipe. The downspouts were connected to the PVC pipes in the trench. The system was covered with soil to assure that the top of the trench was brought back to existing grade so as not to endanger the horses.

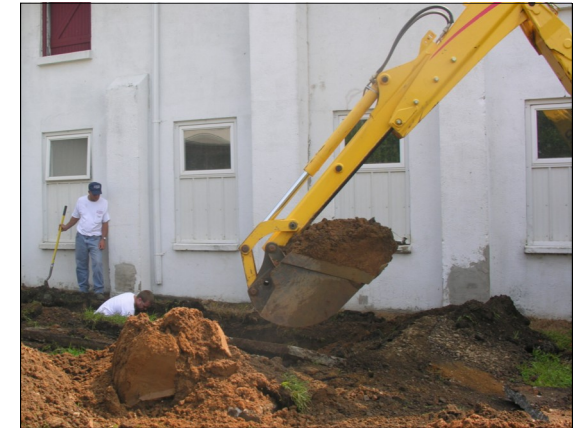
- Rain water from larger storms is now conveyed around the paddock area, discharging this clean water to a drainage swale.
- The system was fairly easy to construct and relatively inexpensive. A three-foot wide, two-foot deep trench was excavated next to the barn.

Excavating the trench

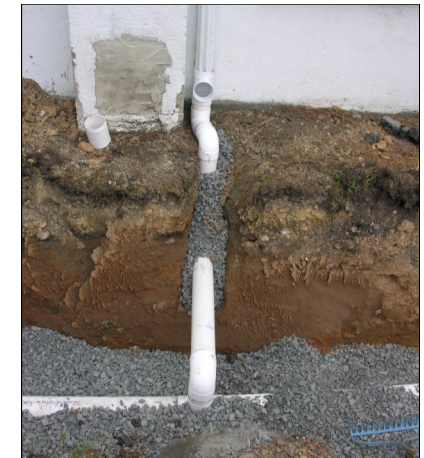
Pipes attached to downspouts and laid in trench; filling trench with gravel
