Demonstration Horse Farm

Best Management Practice Demonstration Horse Farm

Construction of Paddock Drainage (Dry Wells)

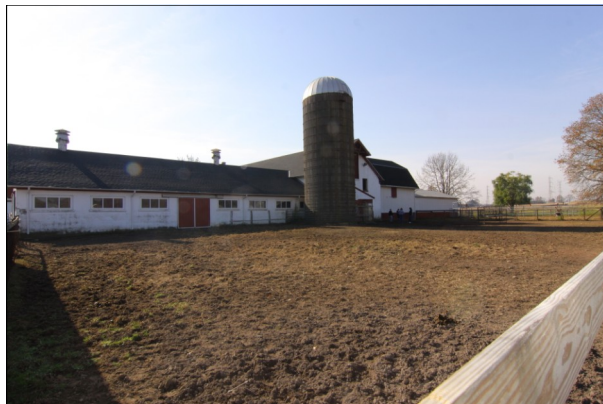
- Rain water no longer flows through the paddock on its way to the waterways, and in turn, no longer ponds there.
- The impact of pollution being carried to the local stream and the threat to horse health is minimized.
- This project represents a relatively simple, inexpensive and effective strategy for reducing contaminated runoff and maintaining the structural quality of a paddock area.

After dry wells

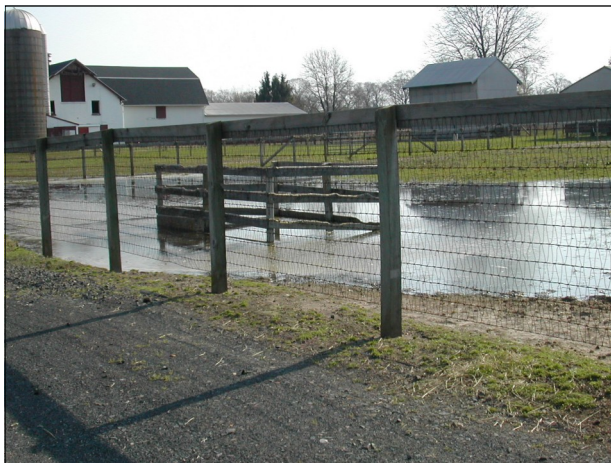
- Stormwater management is a growing concern for equine facilities.
- Regulators are concerned that stormwater runoff carries nutrients and pathogens from facilities into local streams and lakes.
- Paddocks that are adjacent to barns at the Demonstration Horse Farm were the main area of concern.
- The gutter/downspout system on the barn captured relatively clean stormwater runoff from the roof.
- Downspouts discharged the runoff onto the paddock where manure was present.
- Clean water ran through the paddock, mixing with the manure and carrying pollutants off site.
- Additionally, this system of managing roof top runoff made for a muddy paddock, which can have negative health implications for the horses.
- Rain water that landed on the paddock continued to wash soil and manure into a drainage ditch that discharged to a local stream, thereby threatening the health of this waterway.

Drainage problem

- The Rutgers Cooperative Extension Water Resources Program designed an infiltration system to allow rain water from small storms to infiltrate into the ground.

- Rain water from larger storms is now conveyed around the paddock area, discharging this clean water to a drainage swale.
- The system was fairly easy to construct and relatively inexpensive. A three-foot wide, two-foot deep trench was excavated next to the barn.

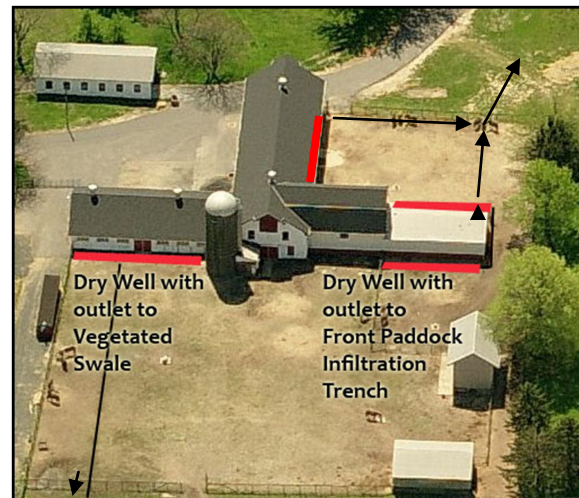
Construction

- Six inches of clean ¾ inch stone was placed in the trench and four-inch diameter perforated PVC piping was placed on top of the stone.
- Additional stone was used to place six inches of cover on the pipe. The downspouts were connected to the PVC pipes in the trench. The system was covered with soil to assure that the top of the trench was brought back to existing grade so as not to endanger the horses.

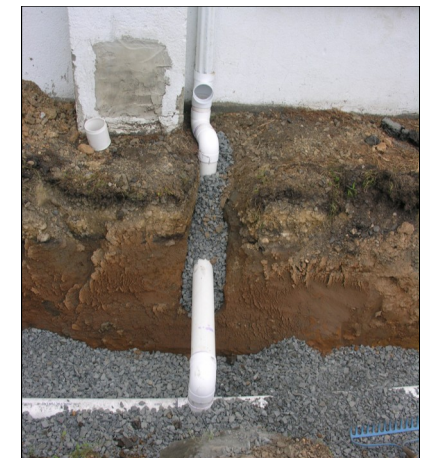
- A PVC-Tee was used to connect the downspouts to the piping in the trench, which serves as an emergency overflow if the PVC piping in the trench ever gets clogged.

Pipes attached to downspouts and laid in trench; filling trench with gravel
